## Abatement and Building Demolition Sequencing at the Former IP Mill, Erving, Massachusetts

**DATE:** March 20, 2023

Erving  
International  
Paper Mill  
Redevelopment

Abatement,  
Demolition, and  
Structural Repair  
Concepts #1 - #4

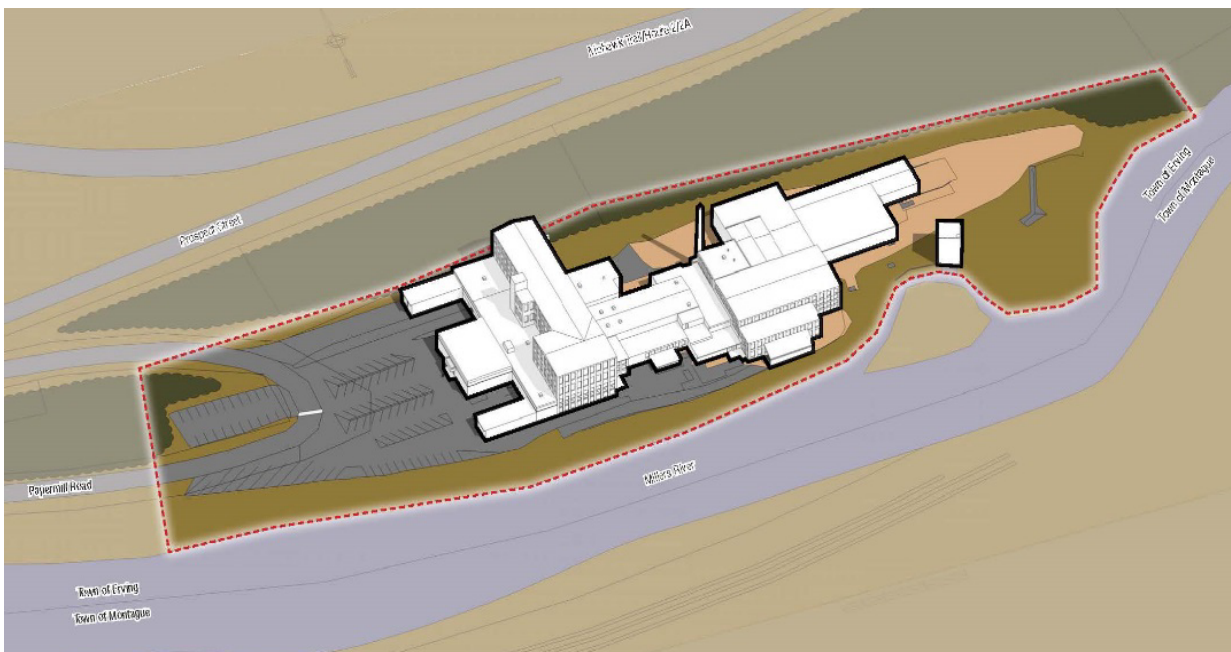
The mill complex is located on a parcel of land that is about 49.3 acres in area and includes a series of buildings. Most buildings are interconnected, and all are part of the mill complex. A pump house, known as Building 8, is also part of the complex but is free standing and located on the riverbank. Building 3 is also a free-standing metal butler type building located a few feet east of Building 2 and previously housed an oil system. The site includes a number of improvements for its use, including a perimeter fence, access drives, asphalt parking lots, and dirt and gravel paths. The north side of the property is a steep wooded embankment leading uphill to Route 2. The south side of the property is a steep riverbank leading downhill to the Millers River.

***Former IP Mill Complex, 8 Papermill Road, Erving, Massachusetts***

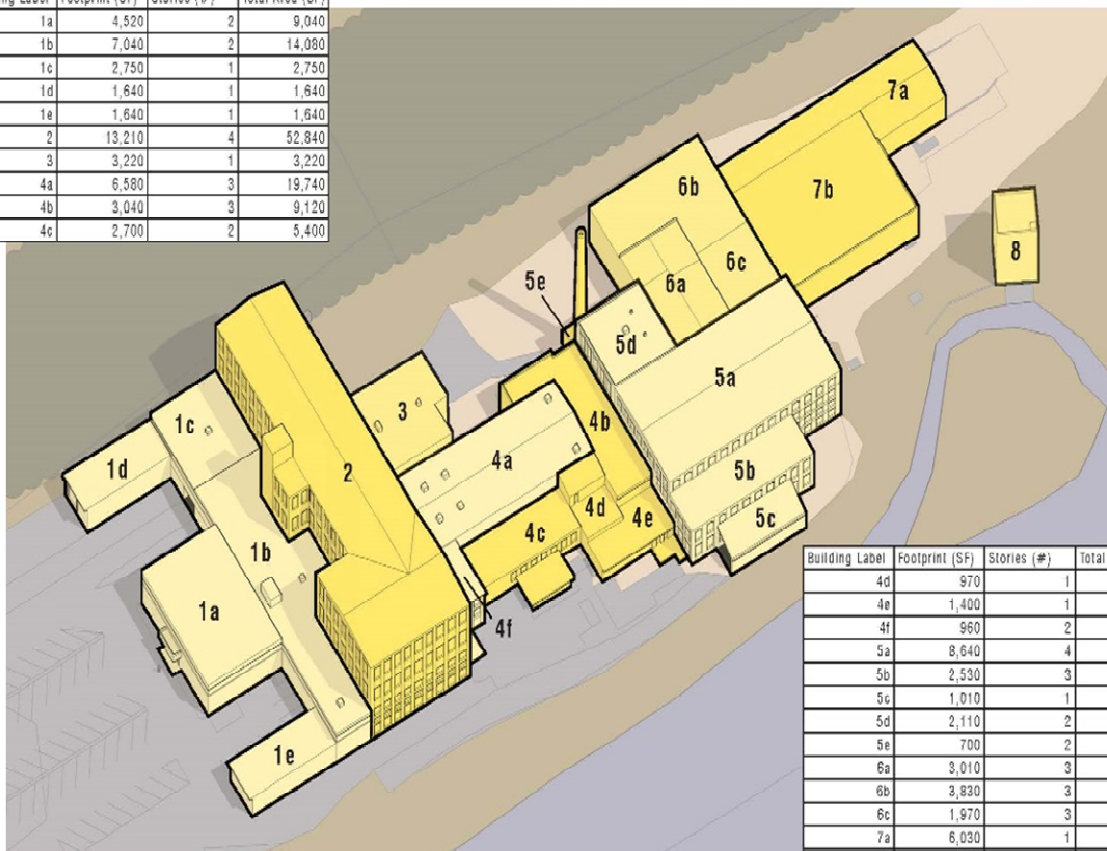
## Former IP Mill Complex – Individual Building Number Designation

Building Label	Footprint (SF)	Stories (#)	Total Area (SF)
1a	4,520	2	9,040
1b	7,040	2	14,080
1c	2,750	1	2,750
1d	1,640	1	1,640
1e	1,640	1	1,640
2	13,210	4	52,840
3	3,220	1	3,220
4a	6,580	3	19,740
4b	3,040	3	9,120
4c	2,700	2	5,400

Building Label	Footprint (SF)	Stories (#)	Total Area (SF)
4d	970	1	970
4e	1,400	1	1,400
4f	960	2	1,920
5a	8,640	4	34,560
5b	2,530	3	7,590
5c	1,010	1	1,010
5d	2,110	2	4,220
5e	700	2	1,400
6a	3,010	3	9,030
6b	2,830	3	11,400
6c	1,970	3	5,910
7a	6,030	1	6,030
7b	5,010	1	5,010
8	690	2	1,380
<b>TOTAL</b>	<b>65,200</b>	<b>-</b>	<b>211,390</b>
